Inspection Report

Cayman Home Inspectors, Ltd.

Date: 6/18/2014	Time: 11:15 AM	Report ID: 1000-110
Property:	Customer:	Real Estate Professional: Juliette Price Cayman Realty Ltd.

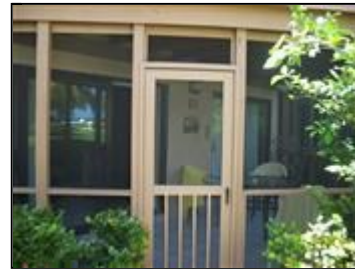
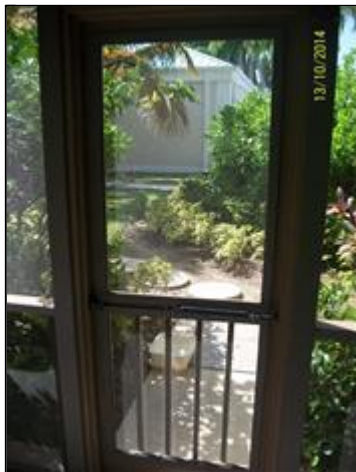
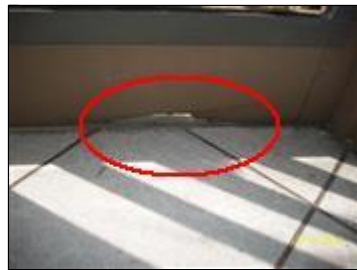
The wooden frame of the screened patio door is damaged at the bottom (see photo 1-3).

If allowed by the strata, recommended is a door replacement, at best, or 'kick plate' along the lower portion of the inner side of the door.

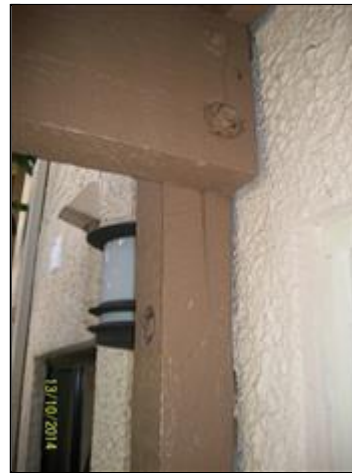
Inspected was the wooden decking & stairway on the exterior of the building, although well maintained, there was an area at the front entrance of the unit (see photo#1 for location & photo#2 for the image) where the wooden beam is splitting, this will be in need of replacement in the future. Usually this is a strata issue.

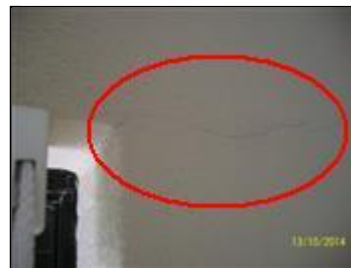
There is a **hairline** crack on the living room wall, this is not unusual in older structures, & caused by settlement of the building.

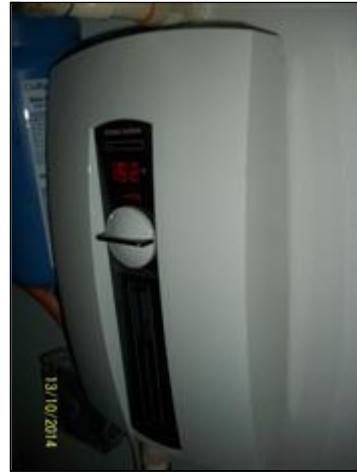
The Hot Water heater used is the "tankless" type, this is located in a shared closet with the air handler.

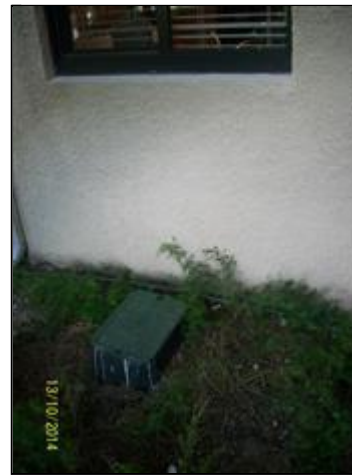
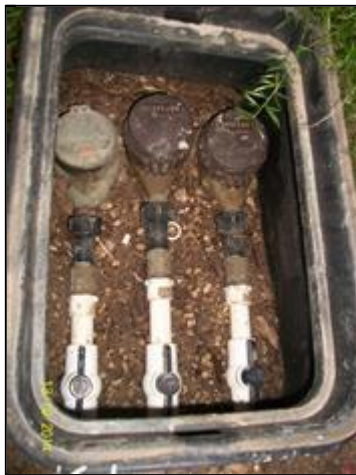
The main water meter is located in the outside planter area next to the front door.

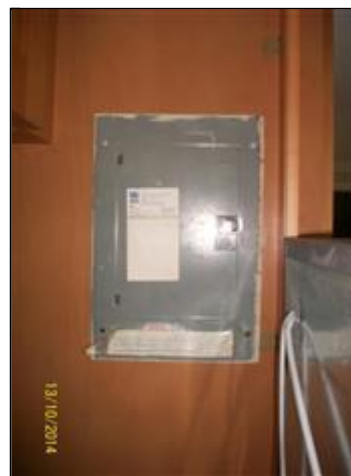
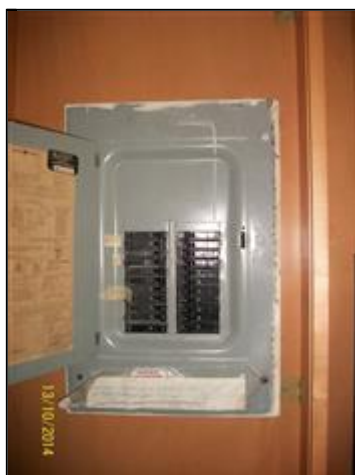
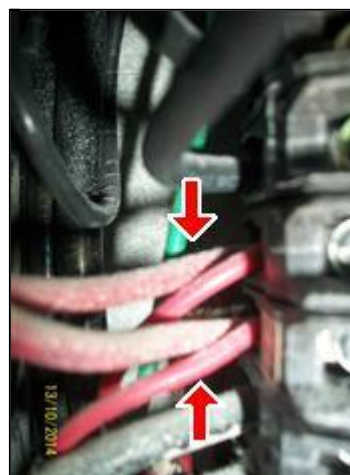
The electrical panel box is located in the Kitchen area beside the refrigerator (see photo#1 for location).

1. The panel box is obstructed from opening freely by the refrigerator, this is a potential safety & fire hazard.
2. On both the right & left side of the breakers, there are double wired breakers (photo#'s 4-6). Over time the wire can work loose
from where it is secured & resulting in irregular current flow to the outlets supplied, overload the circuit breaker & possible FIRE.

1. The electric panel box should be easily accessible & adequate space to service the panel, should the need arise; either re-location
of the panel box, by a licensed electrician or the refrigerator or clothes washer/dryer is advised.
2. Regarding the "*double wired*" breakers these can be re-wired, allowing 1 wire to be connected to the breaker.

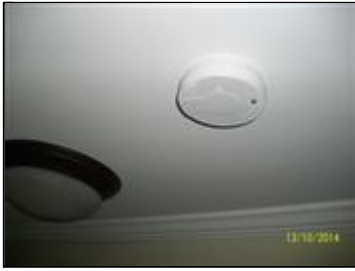
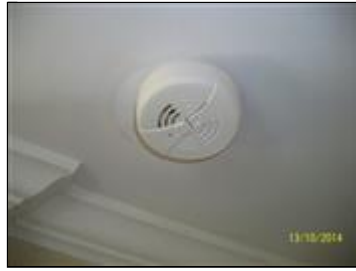
There are 2 smoke detectors on the interior of the unit (see photo#1 for location).

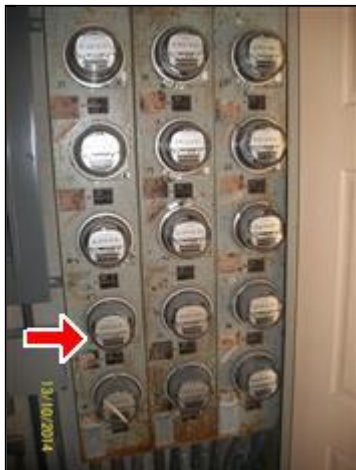
6.9 Picture 1

The Main Electrical Meter is located in a meter room along the walkway between the buildings of the unit & the neighbouring building.

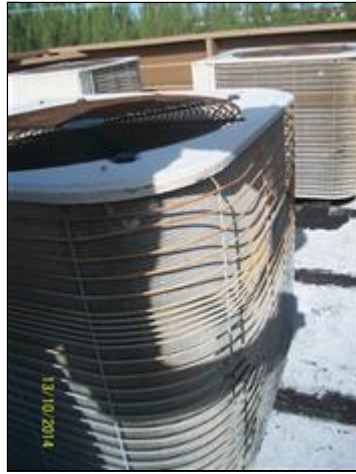
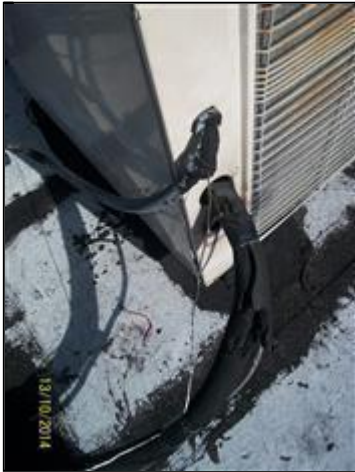
The Air conditioning compressor is located on roof of the building; the unit corresponding to unit 1 is left rear (facing the sea).

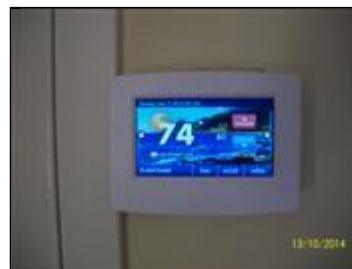
There is 1 digital thermostat operating the air conditioning system, this is located on the Living Room wall (see photo#1 for location).

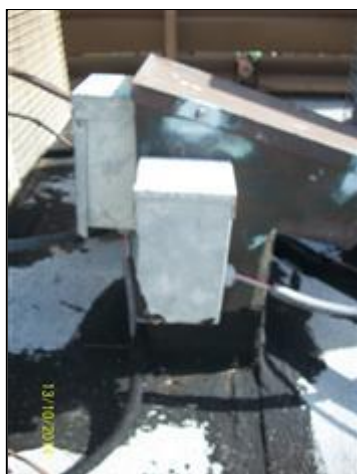
7.2 Picture 1

The air conditioning compressor safety disconnect fuse is located on the roof, in the same area of the compressor.

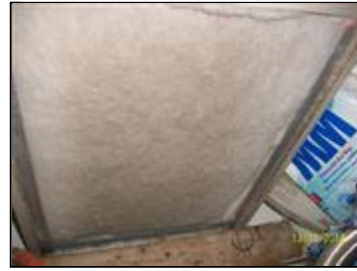
The air conditioning system air filter is located underneath the air handler unit (see photo#1 for location).

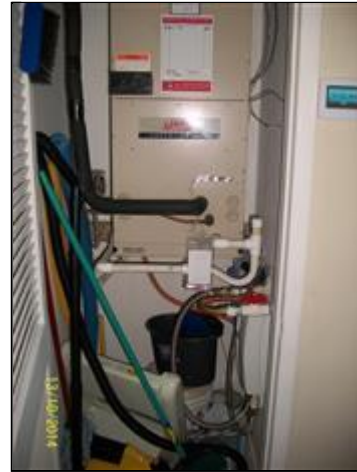
The air handler is in a shared closet with the tankless water heater (see photo#1 for location).

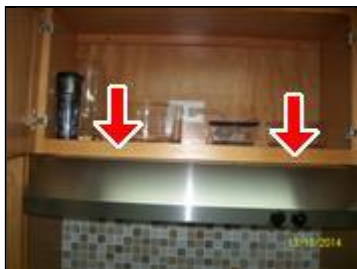
8.0 Picture 1

Each of the bathrooms has functioning exhaust fan. The kitchen exhaust over the cooktop is equipped with a filter where the air passes through.

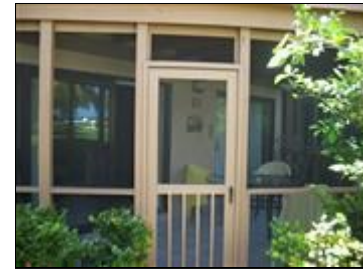
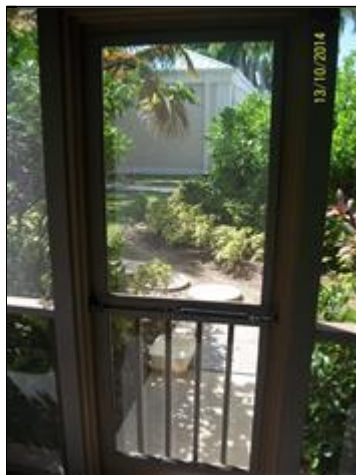
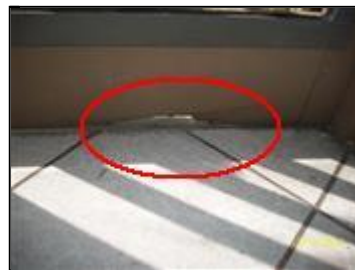
The wooden frame of the screened patio door is damaged at the bottom (see photo 1-3).

If allowed by the strata, recommended is a door replacement, at best, or 'kick plate' along the lower portion of the inner side of the door.

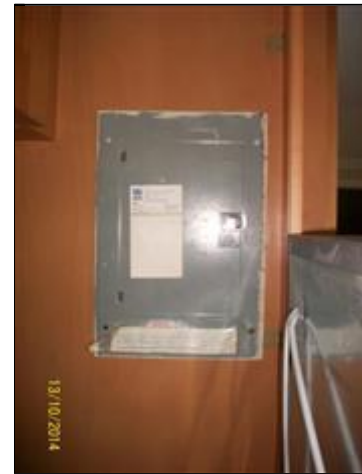
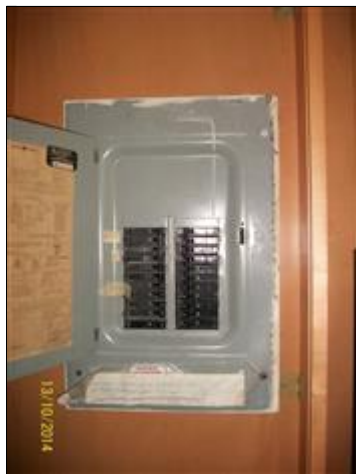
1. The panel box is obstructed from opening freely by the refrigerator, this is a potential safety & fire hazard.

2. On both the right & left side of the breakers, there are double wired breakers (photo#'s 4-6). Over time the wire can work loose

2. Regarding the "*double wired*" breakers these can be re-wired, allowing 1 wire to be connected to the breaker.
